**Flood Control Project Maintenance  
Levee Inspections**

**Fall 2011 Levee Maintenance Deficiency Summary Report**

**Yolo County Planning Resources and Public Works**

Waterway			Bank	Unit Miles
Unit No. 01 Right Bank Cache Creek			Right	0.29
	Spring (March - May)	Summer (June - August)	(September - November) Fall	Winter (December - February)
Unit Maintenance Rating (Fall Only)			<b>U</b>	
Date of Inspection	3/30/2011 - 3/30/2011		10/13/2011 - 10/13/2011	
DWR Inspector	John Williamson		John Williamson	
Accompanied By

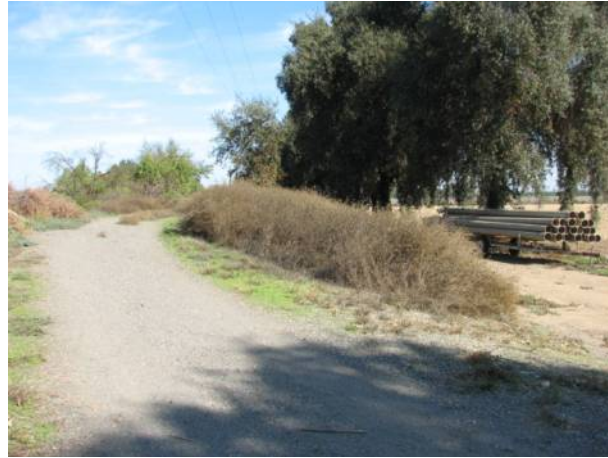
Levee Mile Report Line	1
Start Levee Mile	0.00
End Levee Mile	0.26
Location	Land Side
Category	Earthen Levee
Item	Vegetation
The vegetation is taller than 12 inches tall. Photo taken fall 2011.	
johngw_f_20111024_393.jpg

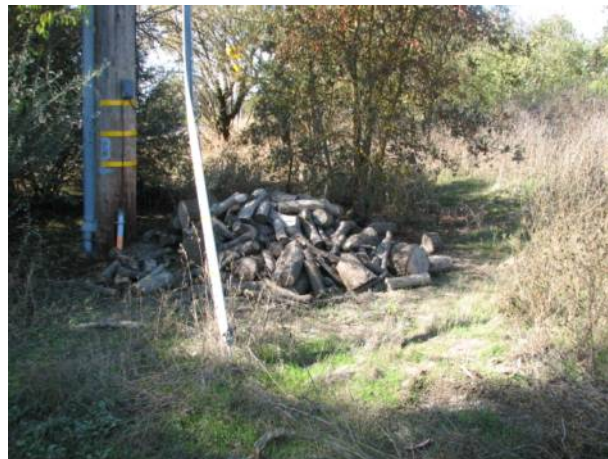
Levee Mile Report Line	2
Start Levee Mile	0.00
End Levee Mile	0.00
Location	Water Side
Category	Earthen Levee
Item	Encroachments
There is firewood piled on the waterside of the levee crown. Photo taken fall 2011.	
johngw_f_20111024_394.jpg

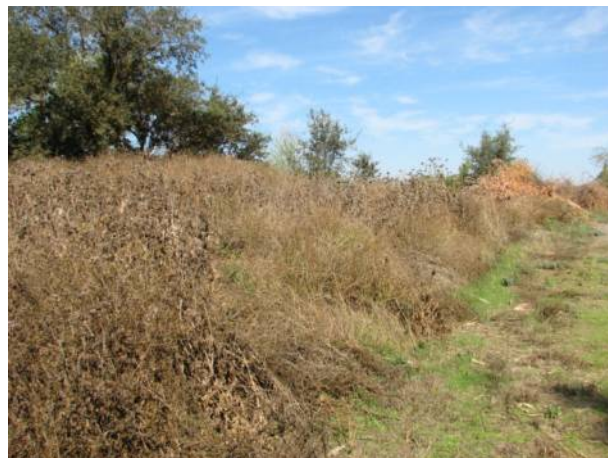
Levee Mile Report Line	4
Start Levee Mile	0.01
End Levee Mile	0.26
Location	Water Side
Category	Earthen Levee
Item	Vegetation
The vegetation is taller than 12 inches. Photo taken fall 2011.	
johngw_f_20111024_395.jpg

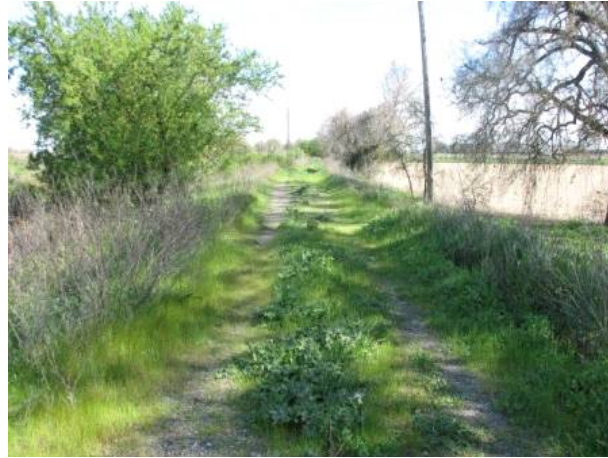
Levee Mile Report Line	5
Start Levee Mile	0.02
End Levee Mile	0.25
Location	Crown
Category	Earthen Levee
Item	Crown Surface / Depressions / Rutting
The vegetation on the crown does not meet standards.	
johngw_f_20110923_906.jpg

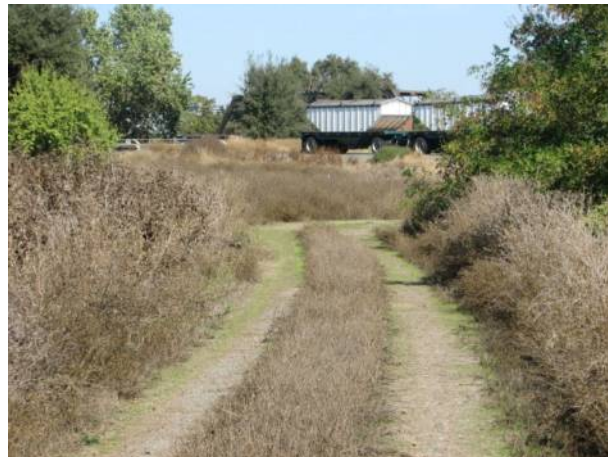
Levee Mile Report Line	5
Start Levee Mile	0.02
End Levee Mile	0.25
Location	Crown
Category	Earthen Levee
Item	Crown Surface / Depressions / Rutting
A current view of the vegetation on the crown photo taken fall of 2011.	
johngw_f_20111024_400.jpg

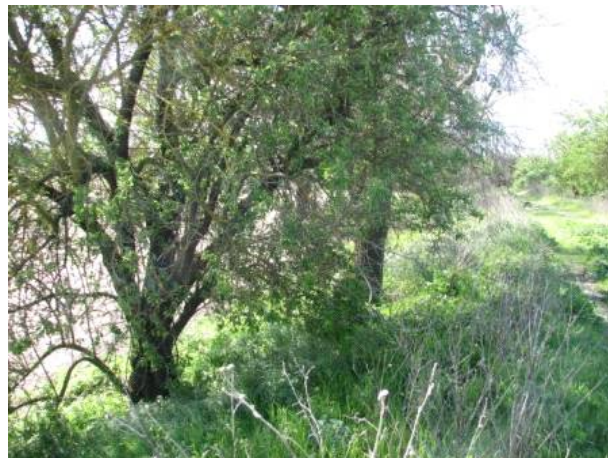
Levee Mile Report Line	7
Start Levee Mile	0.03
End Levee Mile	0.06
Location	Land Side
Category	Earthen Levee
Item	Trim / Thin Trees
The trees need to be thinned and trimmed up for visibility.	
johngw_f_20110923_909.jpg

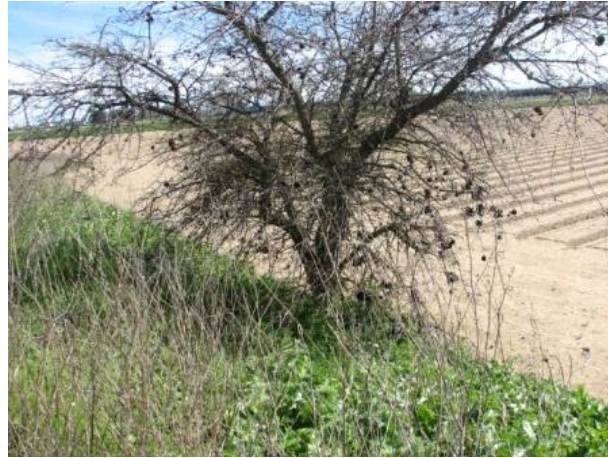
Levee Mile Report Line	8
Start Levee Mile	0.08
End Levee Mile	0.08
Location	Land Side
Category	Earthen Levee
Item	Trim / Thin Trees
The landside tree need to be raised up to meet the standards.	
johngw_f_20110923_910.jpg

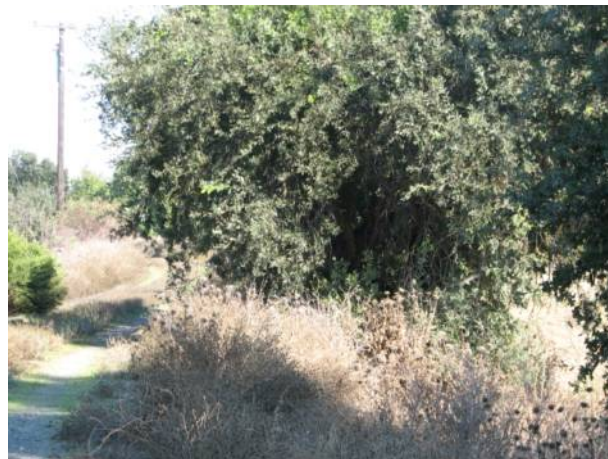
Levee Mile Report Line	9
Start Levee Mile	0.13
End Levee Mile	0.13
Location	Land Side
Category	Earthen Levee
Item	Trim / Thin Trees
The tree on the landside of the levee needs to be trimmed up. Photo taken fall 2011.	
johngw_f_20111024_396.jpg

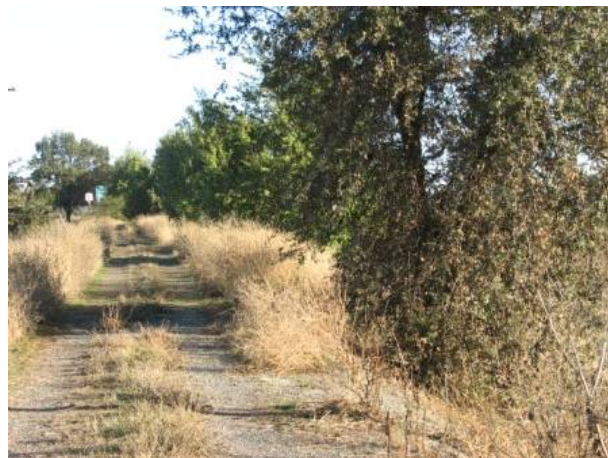
Levee Mile Report Line	10
Start Levee Mile	0.15
End Levee Mile	0.15
Location	Land Side
Category	Earthen Levee
Item	Trim / Thin Trees
All trees on the landside need to be raised. This view is looking downstream.	
johngw_f_20110923_907.jpg

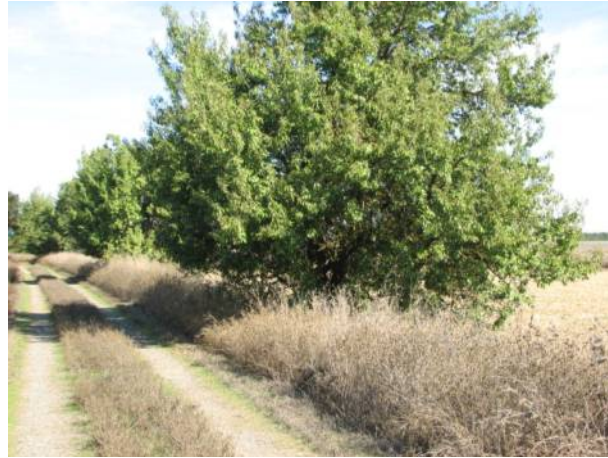
Levee Mile Report Line	11
Start Levee Mile	0.17
End Levee Mile	0.17
Location	Land Side
Category	Earthen Levee
Item	Trim / Thin Trees
The tree needs to be trimmed up for visibility photo taken fall 2011.	
johngw_f_20111024_397.jpg

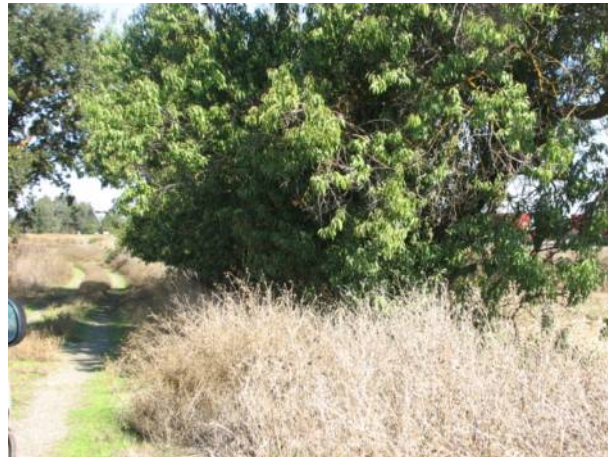
12	0.21	0.21	Earthen Levee	Trim / Thin Trees	LS	M	Trim trees to at least five feet above ground level.	38.725022 ° -121.806478 °	38.725022 ° -121.806478 °	9 Y
13	0.24	0.24	Earthen Levee	Trim / Thin Trees	LS	M	Trim trees to at least five feet above ground level.	38.725427 ° -121.806470 °	38.725427 ° -121.806470 °	10 Y

Levee Mile Report Line	12
Start Levee Mile	0.21
End Levee Mile	0.21
Location	Land Side
Category	Earthen Levee
Item	Trim / Thin Trees
The tree needs to be trimmed up for visibility photo taken fall 2011.	
johngw_f_20111024_398.jpg

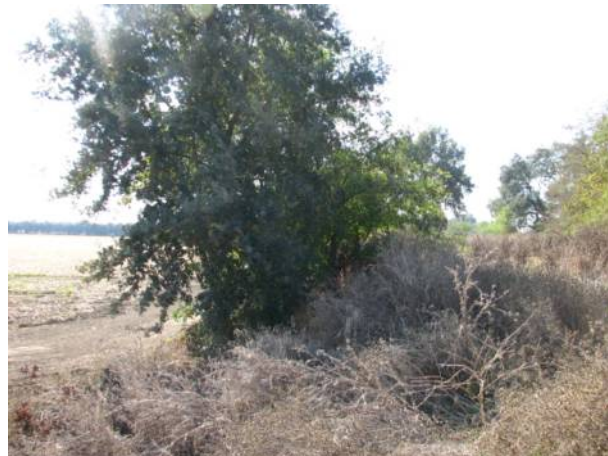
Levee Mile Report Line	13
Start Levee Mile	0.24
End Levee Mile	0.24
Location	Land Side
Category	Earthen Levee
Item	Trim / Thin Trees
The tree needs to be trimmed up photo taken fall of 2011.	
johngw_f_20111024_399.jpg
